DOT/FAA/AR-99/20, P1

Development of a Supplemental Inspection Document for the Fairchild SA226 and SA227 Aircraft, Part 1

Technical Report

REPORT NO. R1517

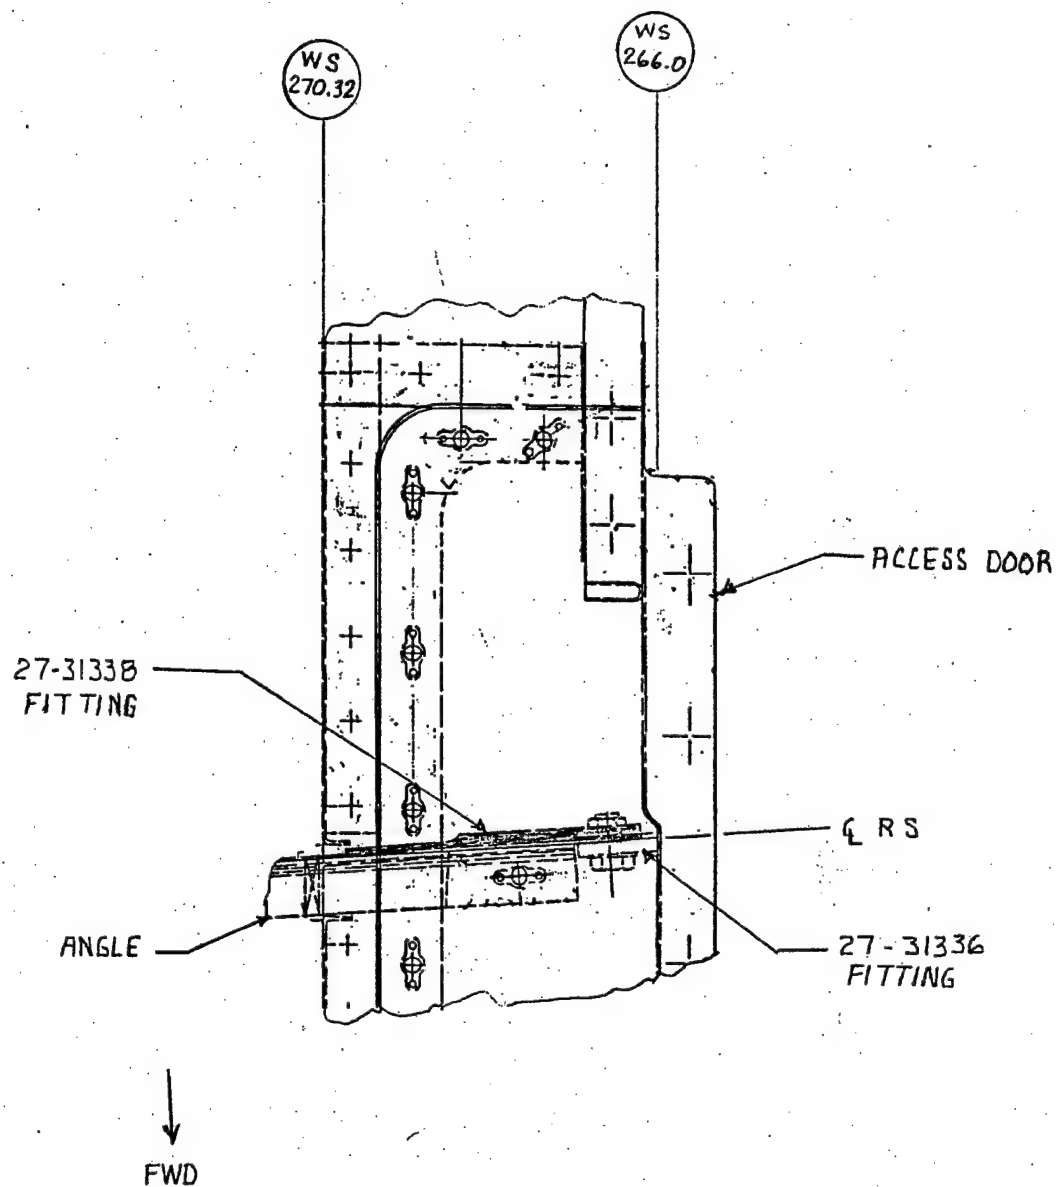
TIP EXTENSION AT END OF OUTBOARD
FITTING REAR SPAR LOWER SURFACE
(SKIN NOT SHOWN)

FIGURE 6-13 W13 - SA227 TIP EXTENSION AT END OF
OUTBOARD FITTING (REAR SPAR)

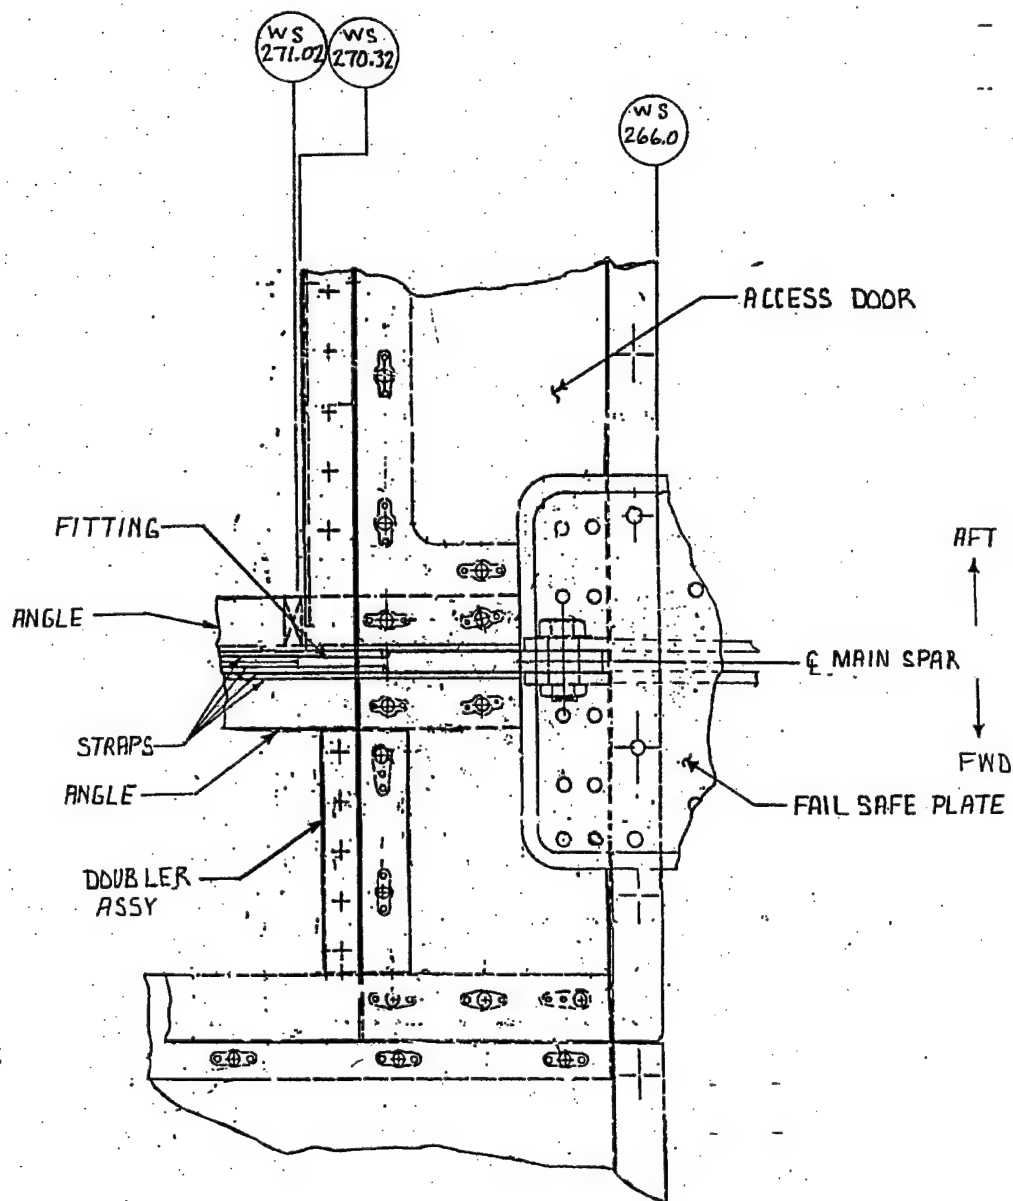
WING TIP EXTENSION AT END OF
OUTBOARD FITTING MAIN SPAR
LOOKING UP LOWER SURFACE
(SKIN NOT SHOWN)

**FIGURE 6-14 W14 - SA227 TIP EXTENSION AT END OF
OUTBOARD FITTING (MAIN SPAR)**

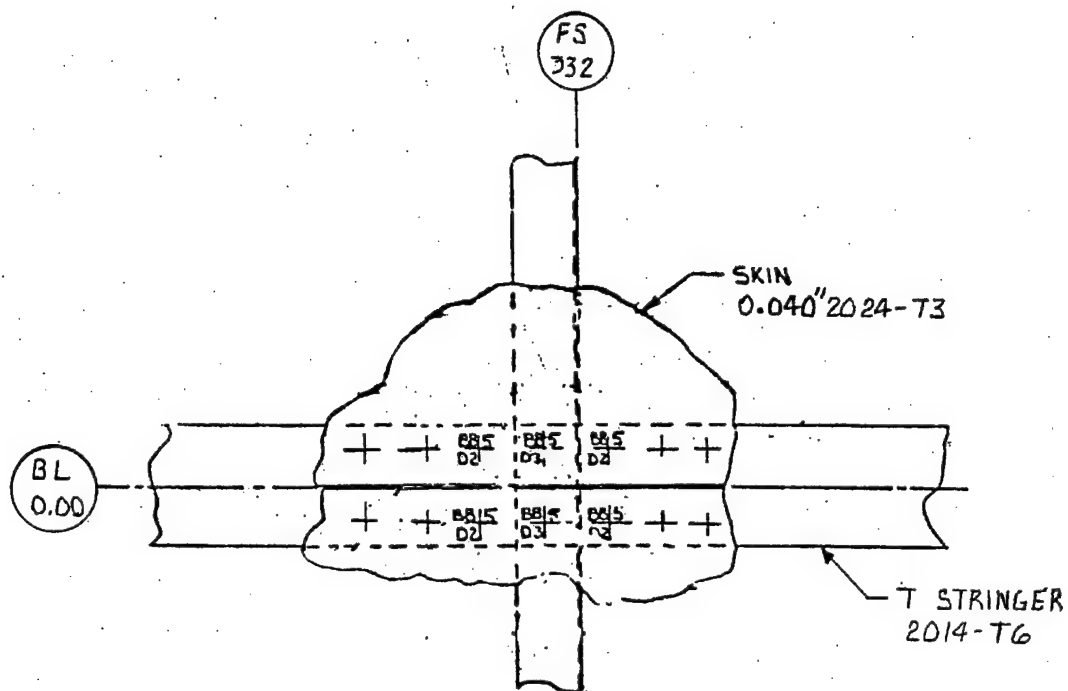
T STRINGER TOP CENTERLINE
NEAR FS 330

FIGURE 6-15 F1 - SA226 T STRINGER, TOP CENTERLINE
NEAR F.S. 330

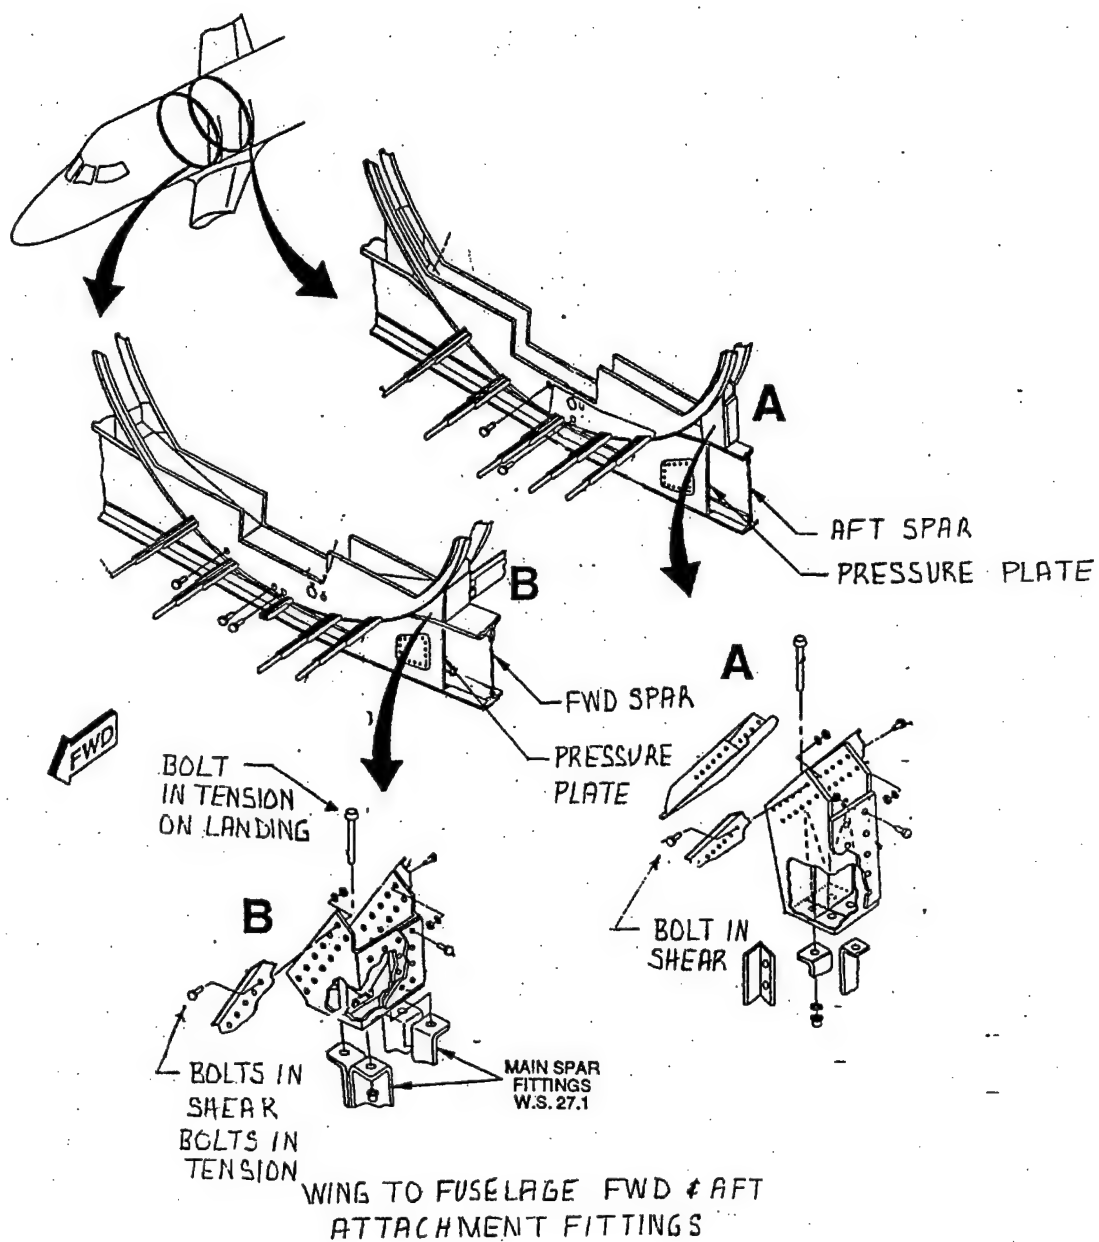
FIGURE 6-16 F2 AND F3 - SA226 AND SA227 WING FUSELAGE FORWARD ATTACHMENT FITTINGS

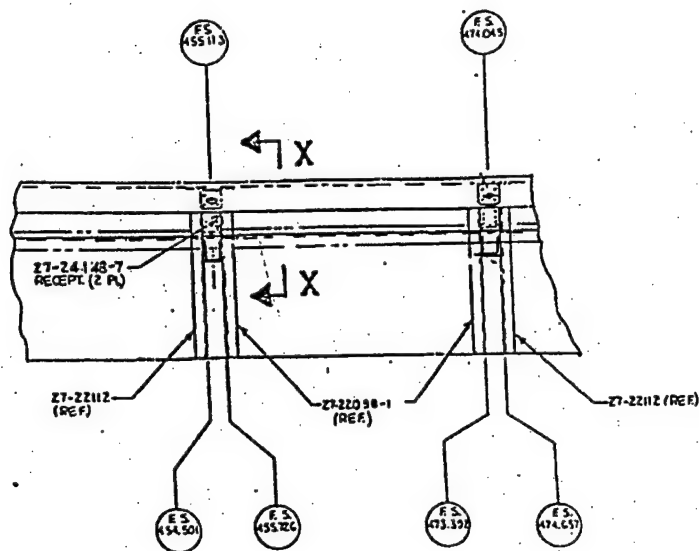
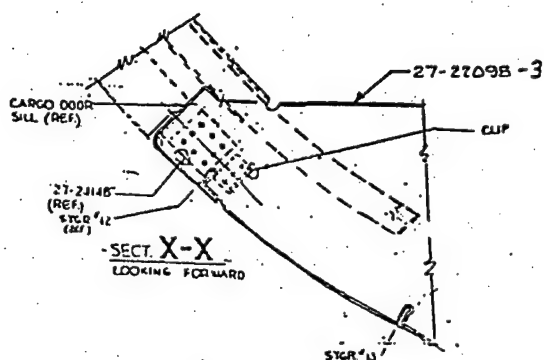
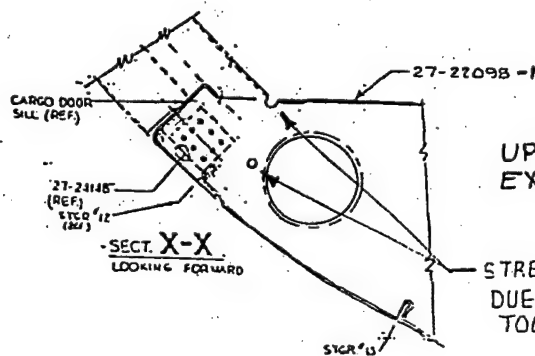
VIEW LOOKING INBD - L.H. SIDE
SKIN / DOOR OMITTED FOR CLARITY

SN 479 & UP

UP TO SN 479
EXCEPT 457 & 470

STRESS CONCENTRATION
DUE TO NOTCH AND
TOOLING HOLE

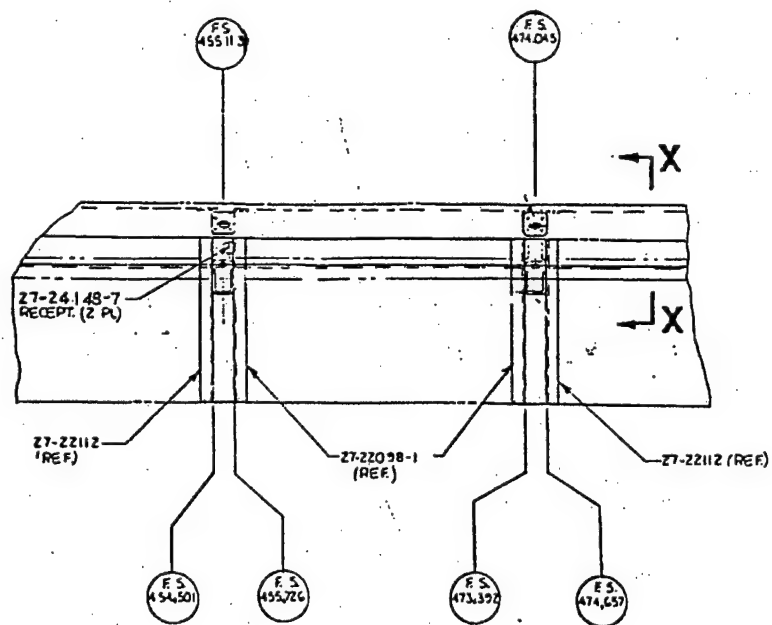
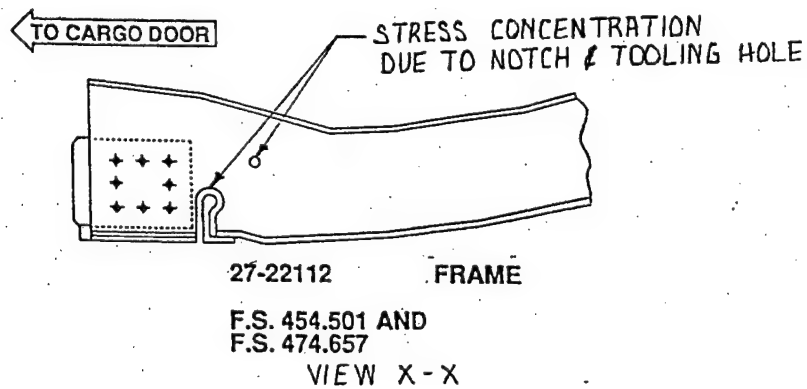
FIGURE 6-18 F5 - SA226 AND SA227 FUSELAGE FRAME AT CARGO DOOR LATCH

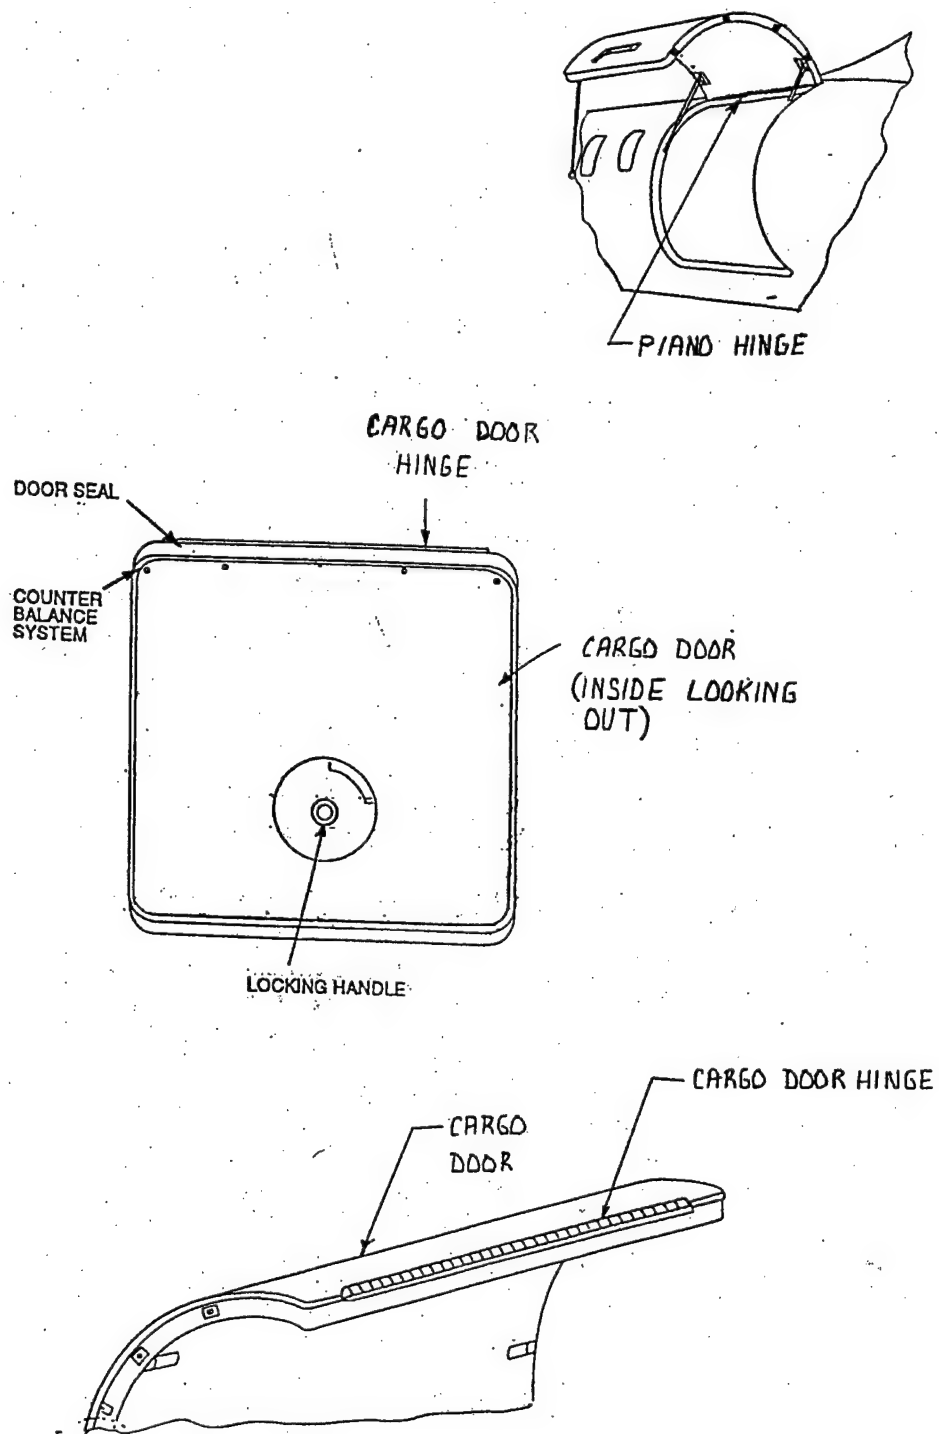
FIGURE 6-20 F7 - SA226 AND SA227 CARGO DOOR HINGE

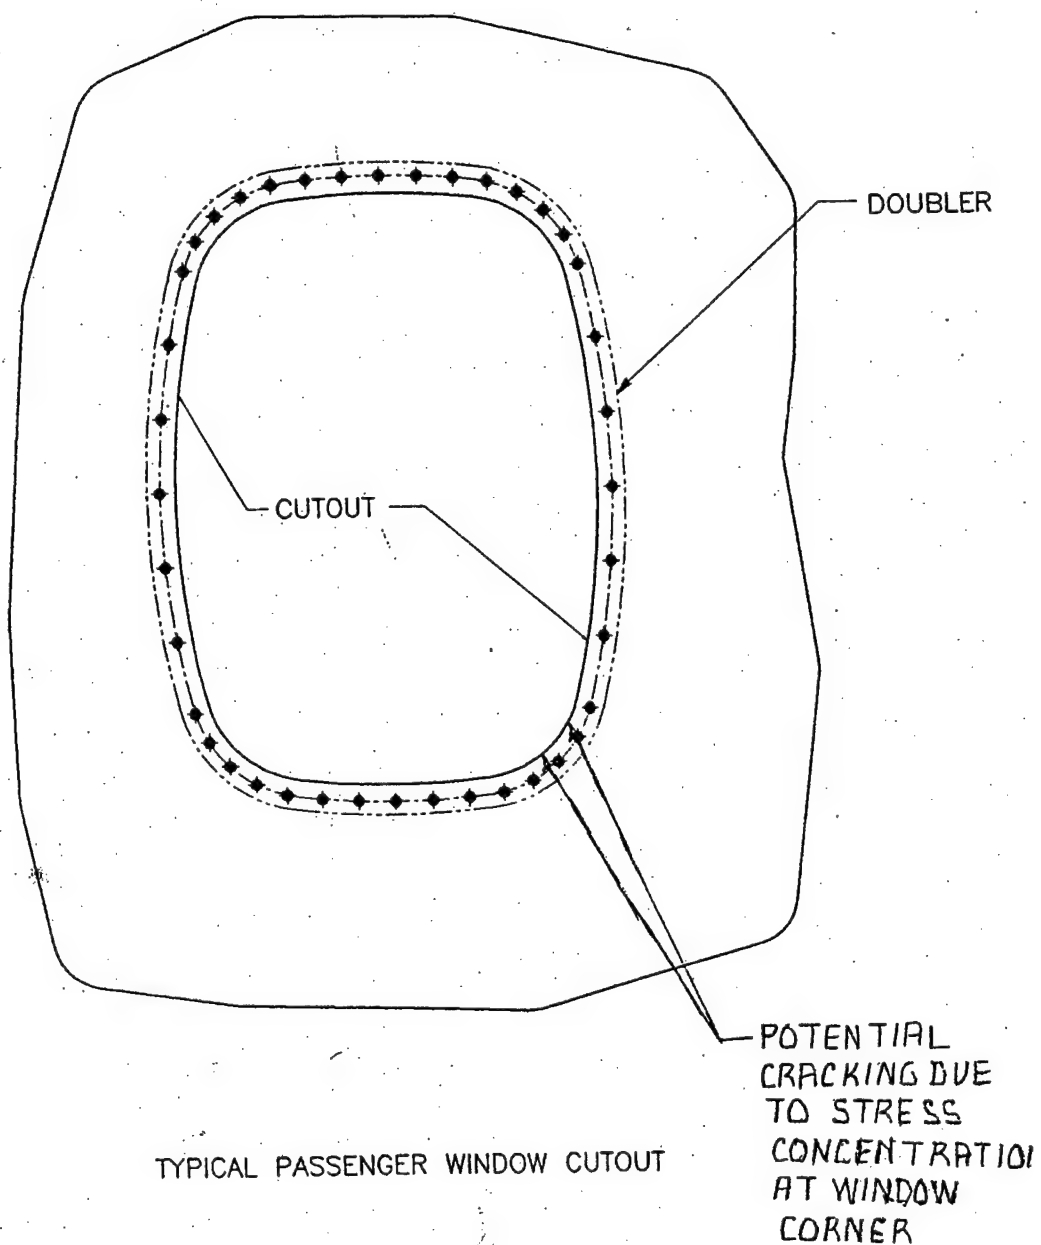
FIGURE 6-21 F8 - SA226 AND SA227 CORNERS OF PASSENGER WINDOW CUTOUTS

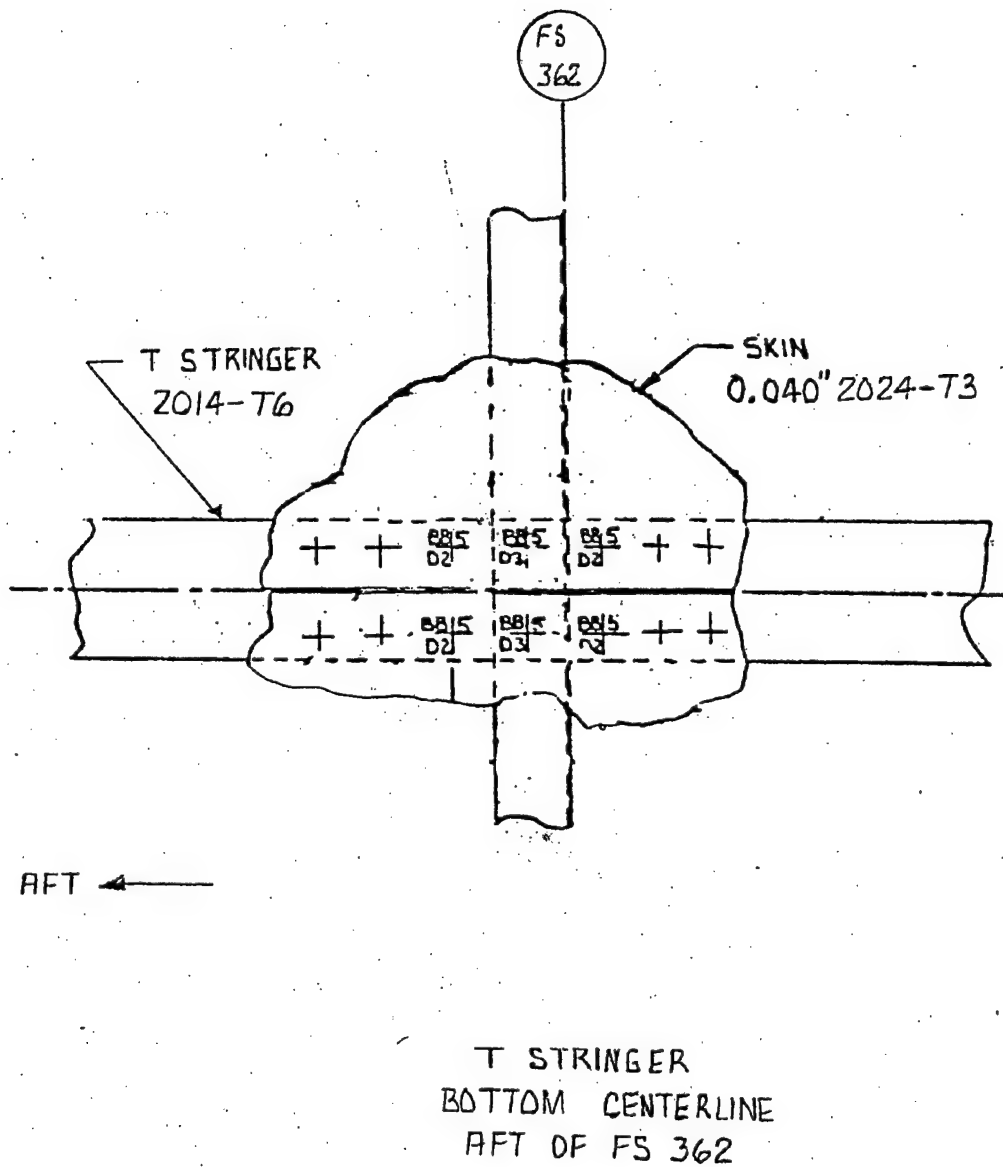
FIGURE 6-22 F9 - SA226 T STRINGER, BOTTOM CENTERLINE
 AFT OF F.S. 362

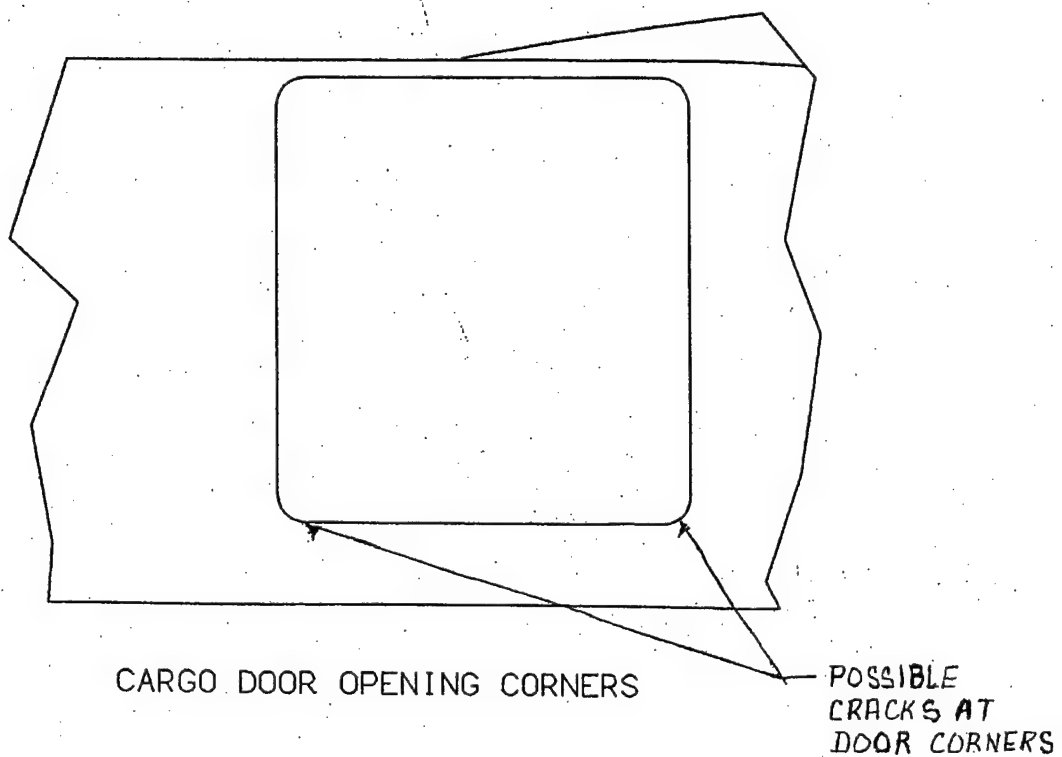
FIGURE 6-23 F10 - SA226 AND SA227 CARGO DOOR OPENING CORNERS

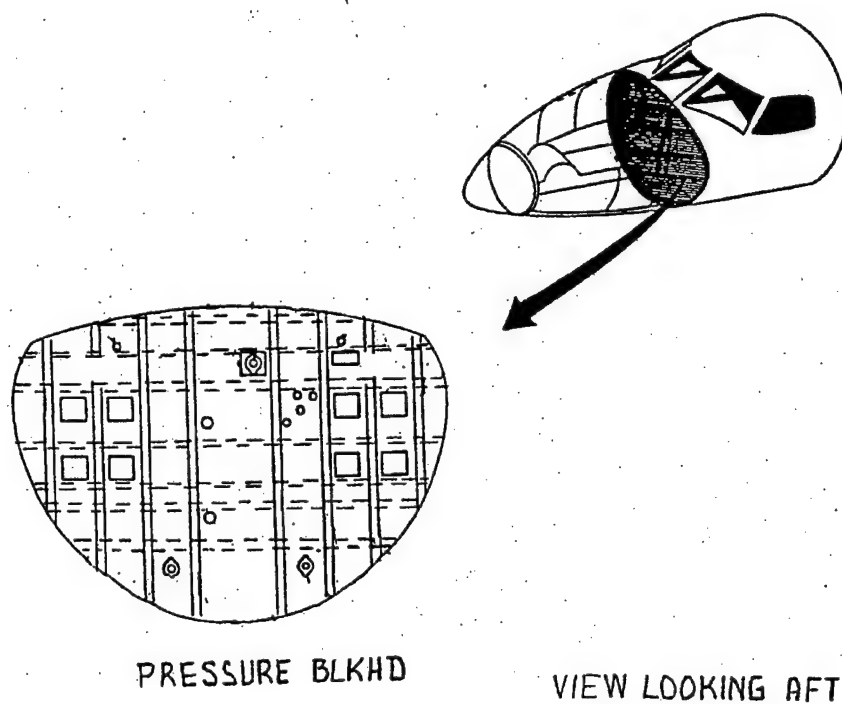
Nose Section, Bulkhead - F.S.69.31

FIGURE 6-24 F11 - SA226 AND SA227 FORWARD PRESSURE BULKHEAD

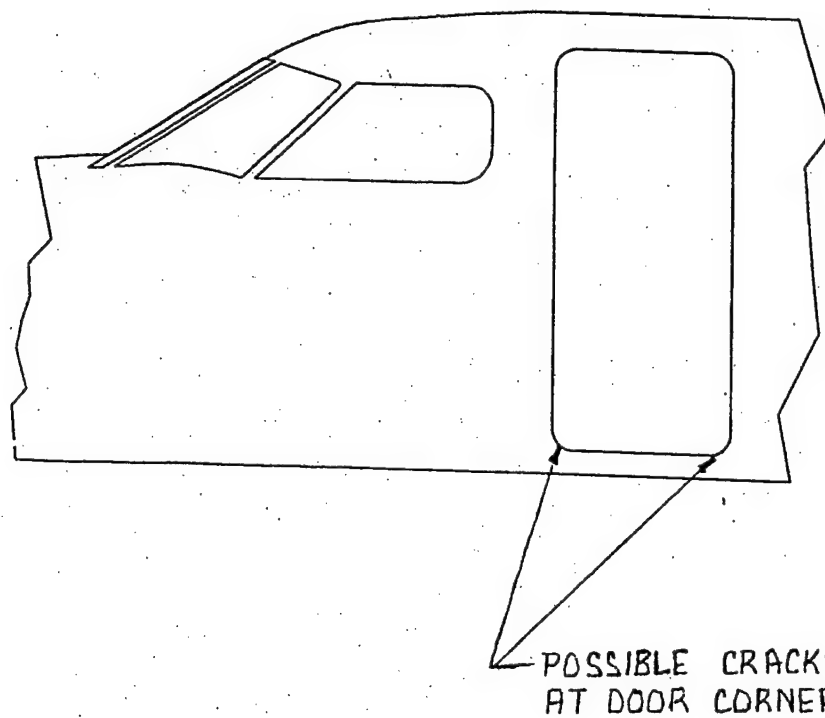
**FIGURE 6-25 F12 -SA226 AND SA227 PASSENGER DOOR
OPENING CORNERS**

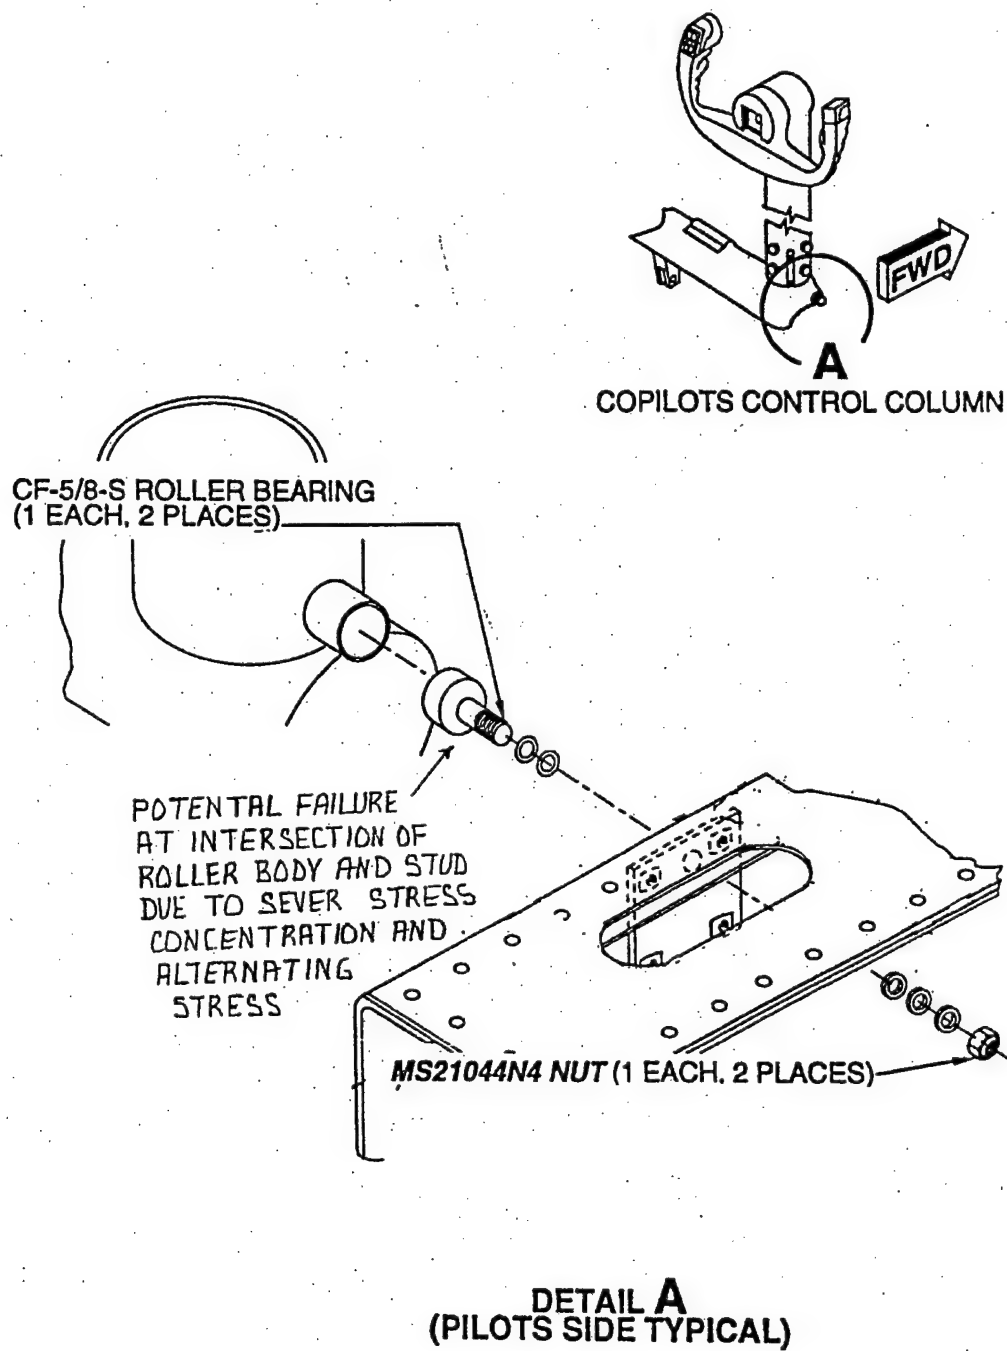
**FIGURE 6-26 F13 - SA226 AND SA227 CONTROL COLUMN
ROLLER BEARING**

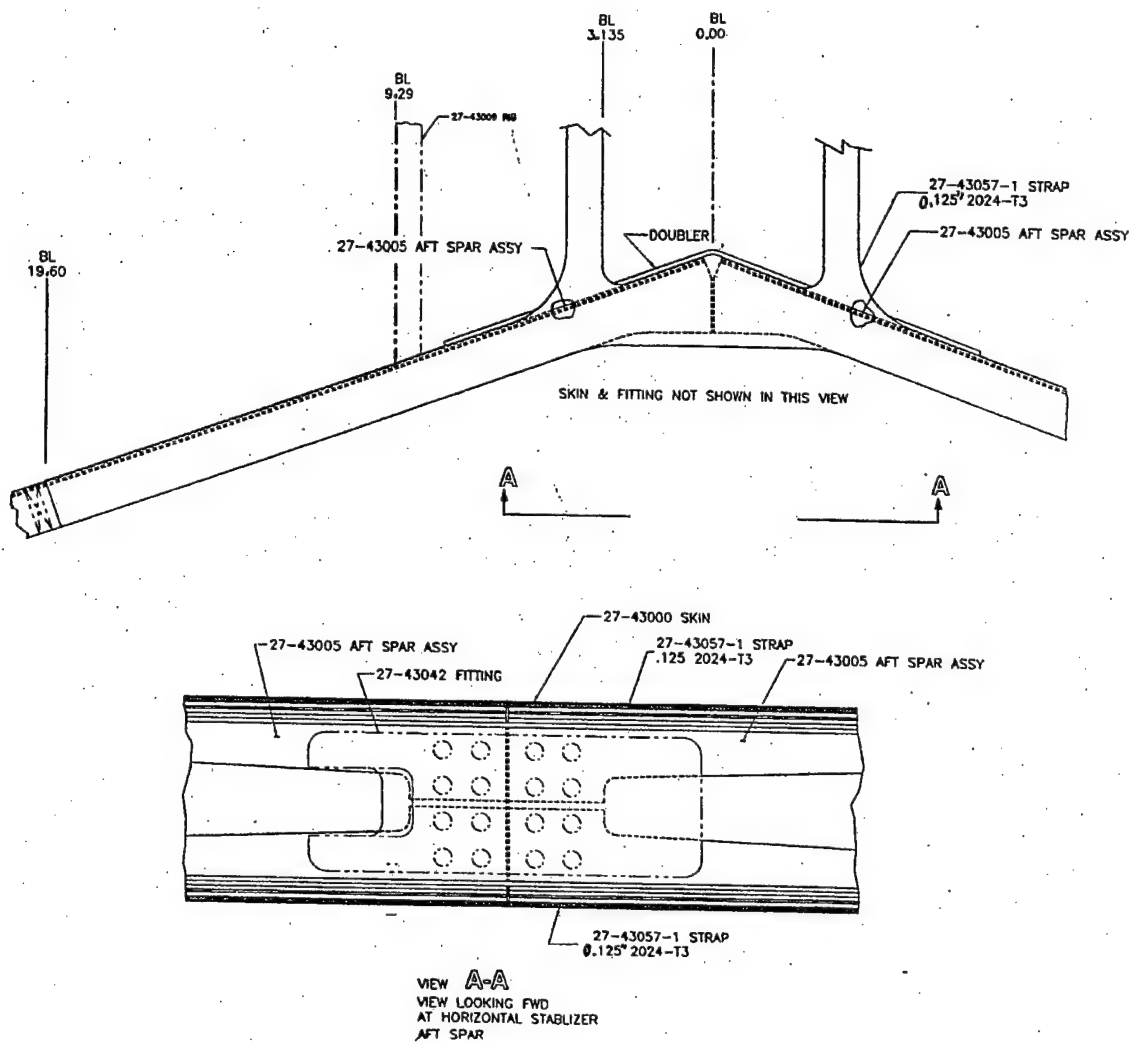
**FIGURE 6-27 H1 - SA226 AND SA227 HORIZONTAL STABILIZER
RIB STRAP AT REAR SPAR**

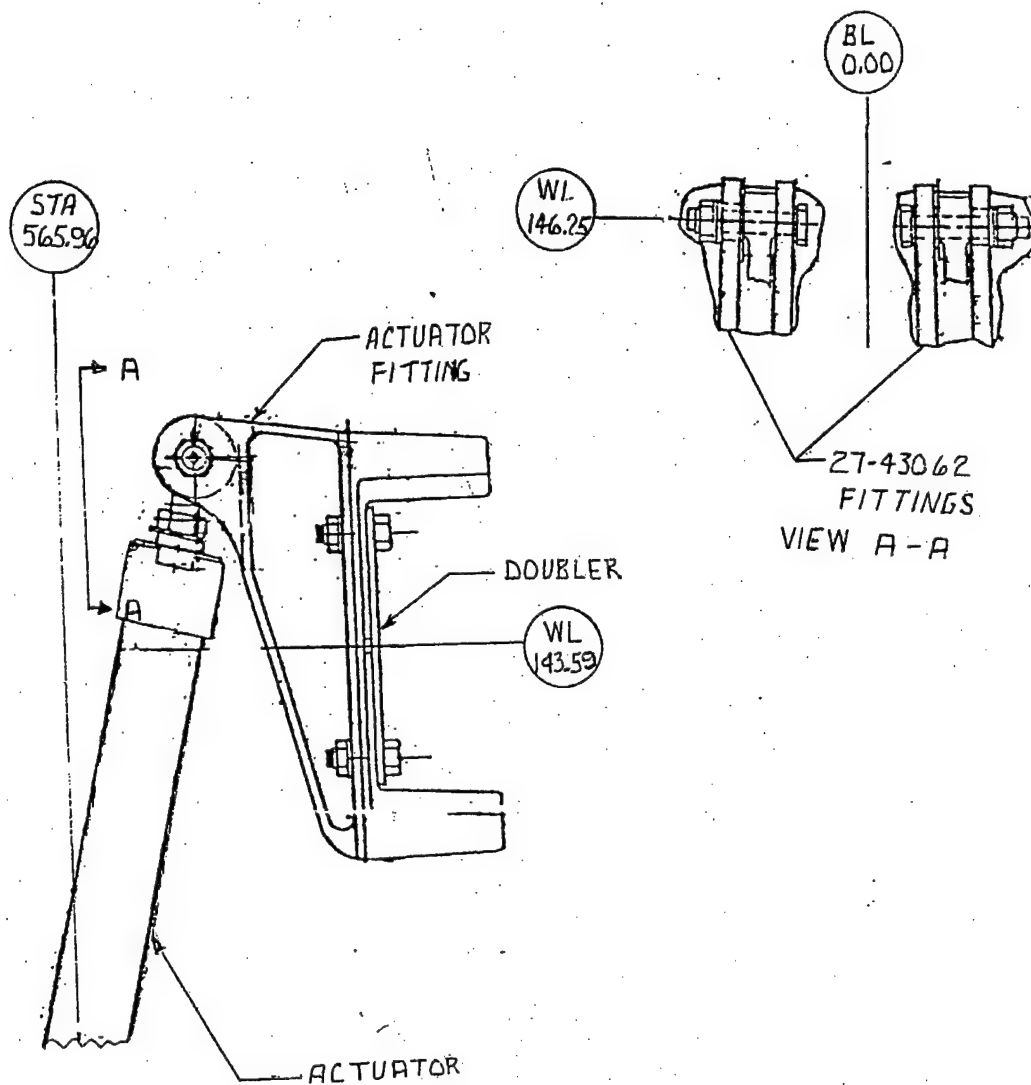
FIGURE 6-28 H2 – SA226 AND SA227 HORIZONTAL STABILIZER PITCH TRIM ACTUATOR FITTINGS

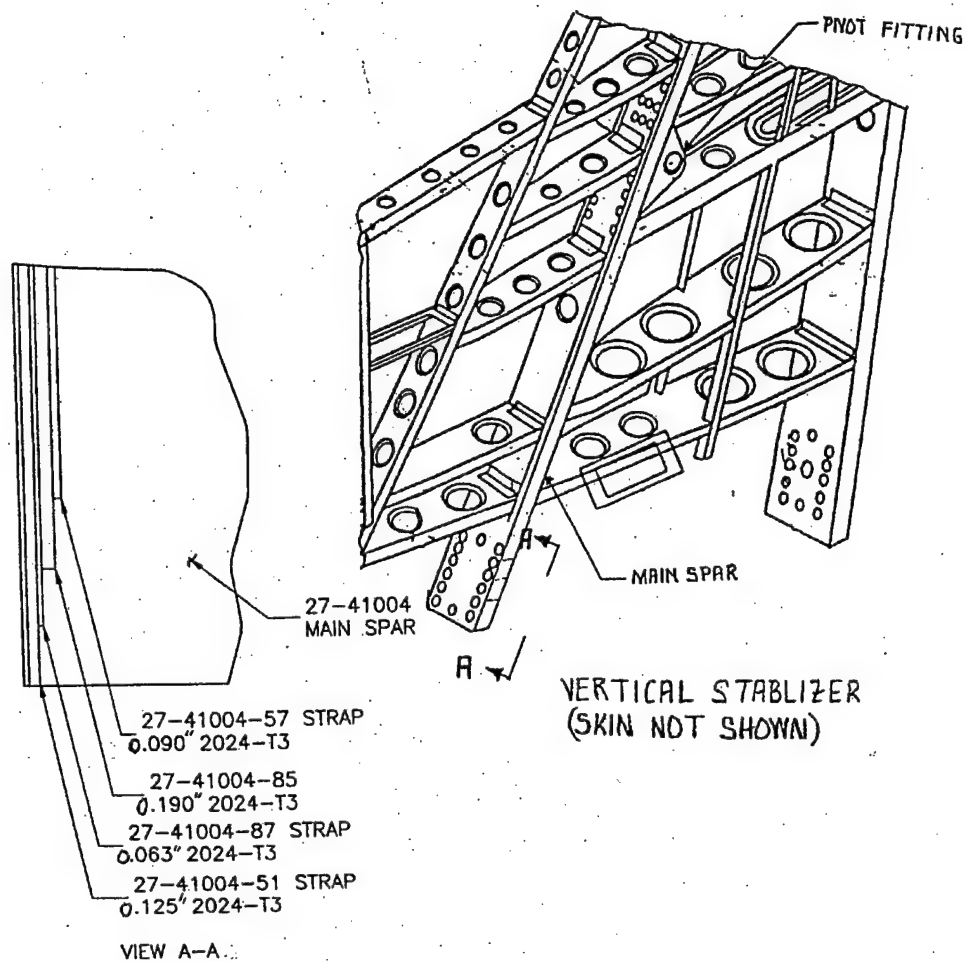
**FIGURE 6-31 V1 – SA226 AND SA227 VERTICAL FIN MAIN SPAR
CAP STRIPS**

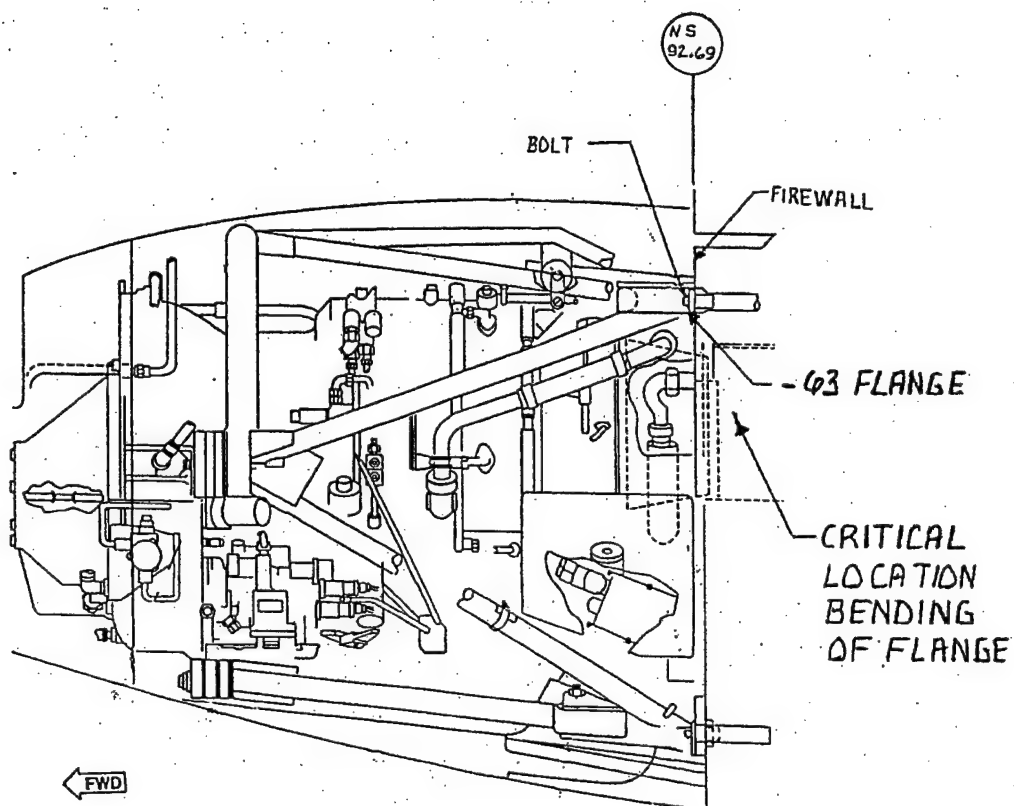
FIGURE 6-32 EM1 - SA227 ENGINE MOUNT AT FIREWALL

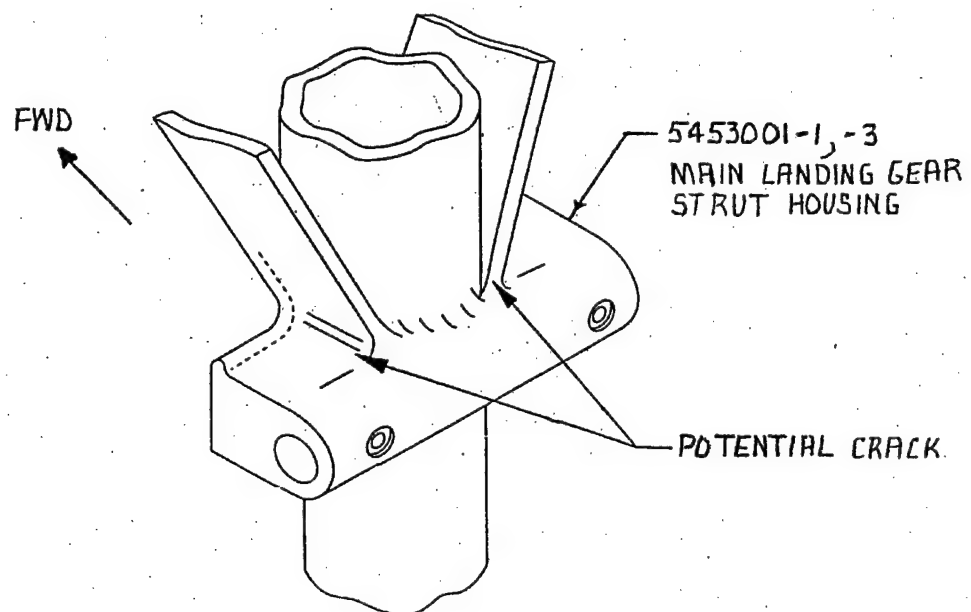
FIGURE 6-33 LG2 - MAIN LANDING GEAR STRUT

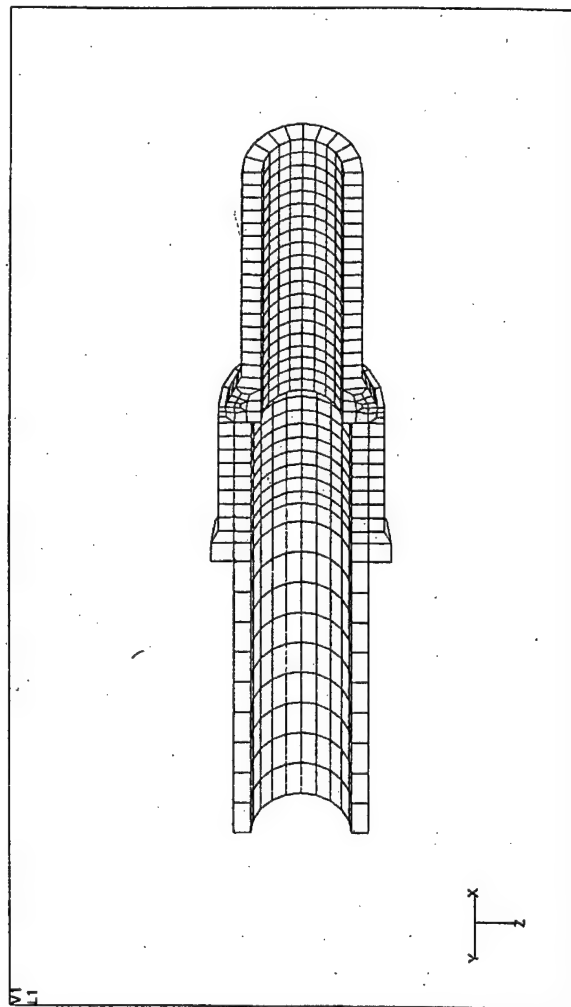
FIGURE 6-34 METRO III MAIN LANDING GEAR FINITE ELEMENT MODEL

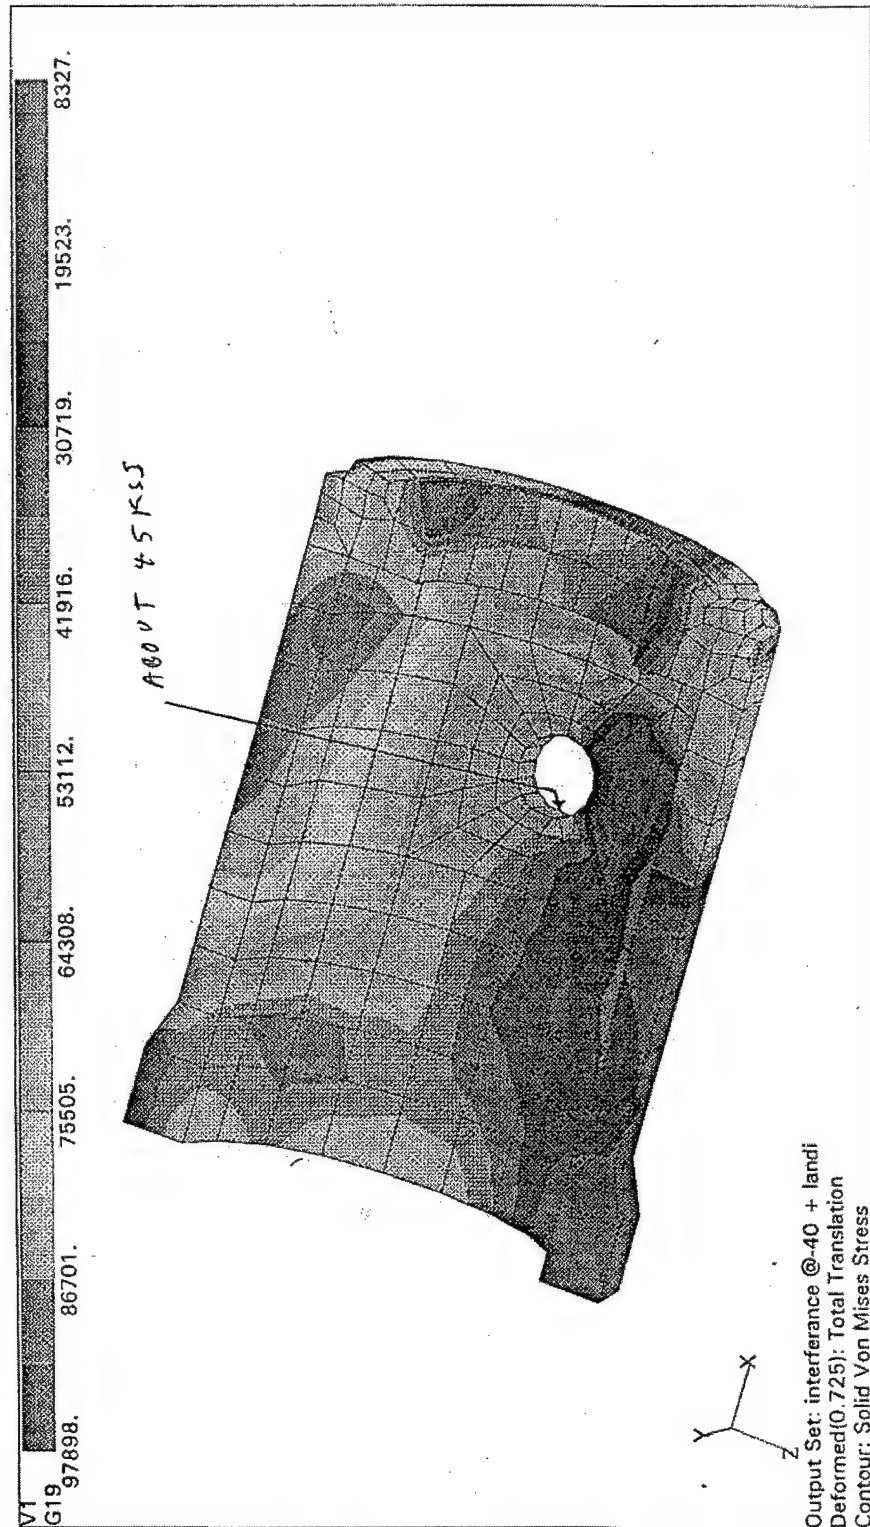
FIGURE 6-35 MAIN LANDING GEAR FINITE ELEMENT MODEL

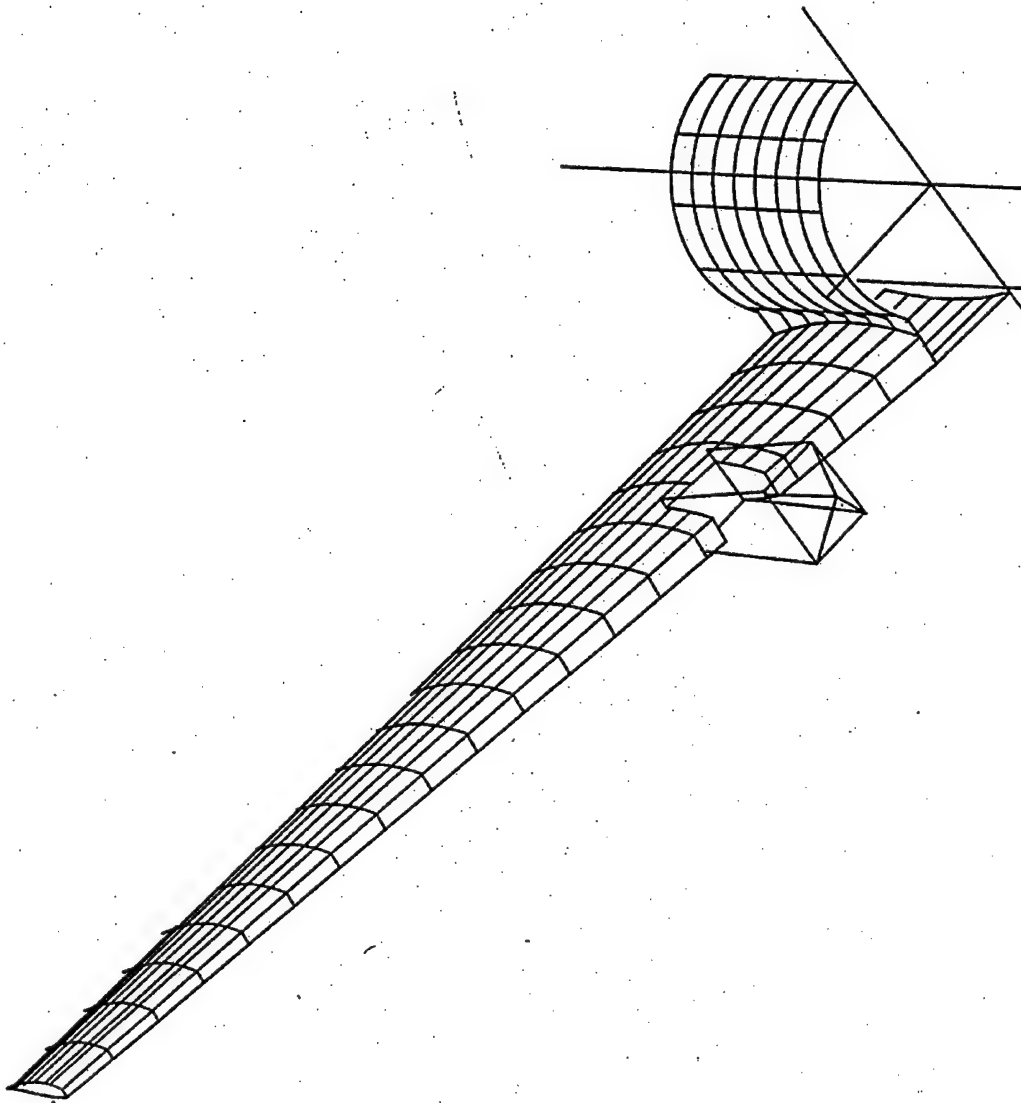
FIGURE 6-36 WING FINITE ELEMENT MODEL

The wing finite element model shown in Figure 6-36 was used to analyze the SA227 wing. The distributions were checked during the SA227 wing static test and shown to be within about 1% of the measured stress for the more heavily loaded portions of the wing. These analysis results can be used to determine stresses at locations other than the strain gage locations.

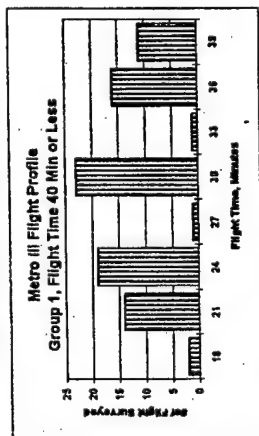
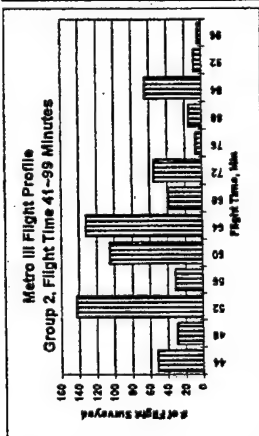
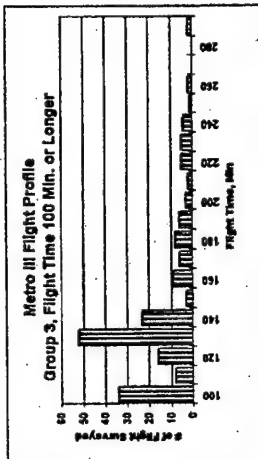
B-2

MISSION PROFILE SELECTION FLIGHT LENGTH COMPARISON

Time (+1 std dev) 36
Time, Average 29
Time (-1 std dev) 23

Time (+1 std dev) 74
Time, Average 62
Time (-1 std dev) 50

Metro III Flight Time Surveys, STD DEV CAL
Group 1, 40 minutes or less

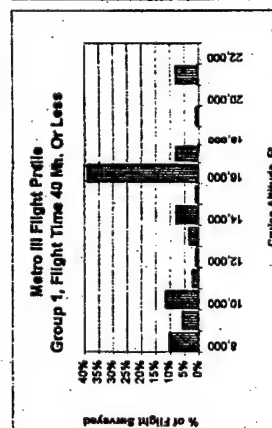
B-6

MISSION PROFILE SELECTION FLIGHT ALTITUDE COMPARISON

Metro III Altitude Survey
Group 1, 40 minutes or less

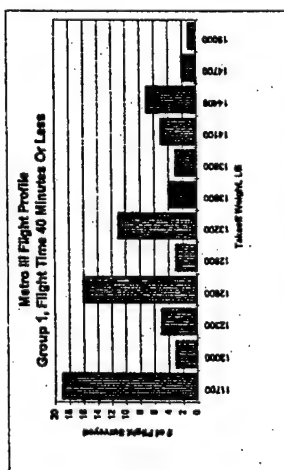
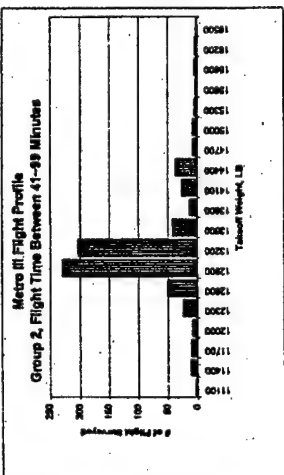
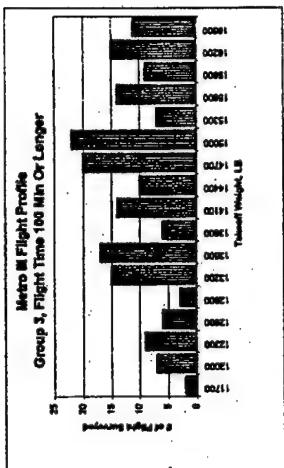
MISSION PROFILE SELECTION TAKEOFF WEIGHT COMPARISON

Wt. (+1 std dev) 13,765
Wt. Average 12,733
Wt. (-1 std dev) 11,741

Wt. (+1 std dev) 13,901
Wt. Average 13,274
Wt. (-1 std dev) 12,647

Wt. (+1 std dev) 14,918
Wt. Average 13,828
Wt. (-1 std dev) 12,737

Metro III Weight Surveys
